APPLICATION OF DOW-QUASH TO LIMITING COMMUNITY NOISE

By Corjan Buma, M.Sc., P.Eng.

Published in Canadian Acoustics 2003 Acoustics Week In Canada Proceedings Issue

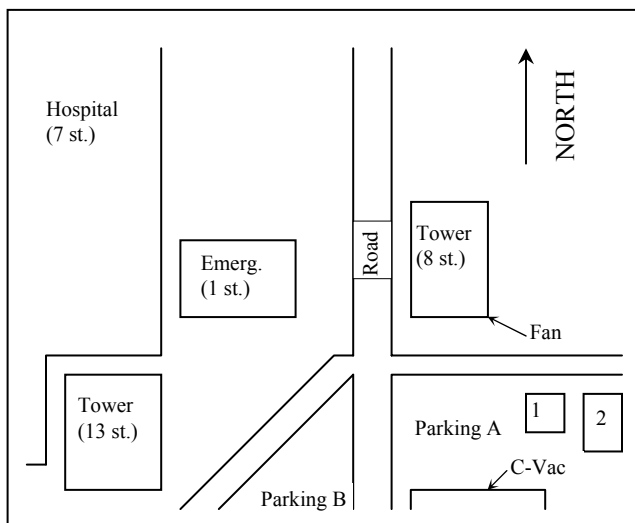
Figure 1 – Area Plot Plan

Figure 1 shows a macroscopic view of the study area. Of note are the large teaching Hospital, the 13-storey research tower with mechanical penthouse, a central-vacuum outlet recessed in a loading dock in close proximity to the noise-affected Residence and the restaurant exhaust fan. In the quietest night-time hours traffic flows on the Roadway typically reduced to one vehicle pass-by every minute or so. The Hospital had a major roof-mounted noise source (exhaust unit) on its south wing which was significantly shielded from the noise-affected Residence (Fig. 1, “2”) by the Research Tower. The Hospital also had numerous additional ventilation intakes and outlets on the upper storey of its east face as well as its Emergency ward at grade on the east side. The central vacuum system of the south high-rise did not stop at the same time each night; it had a generally low-frequency signal that was clearly audible across the Parking Lot. The Restaurant exhaust fan on the north high-rise was mounted at essentially the height of the second floor and initially ran continuously.

The second and third measurement sets involved short-term 1/3-octave sound level logging while ALL penthouse noise sources atop the Research Tower were progressively shut off and returned to normal operation. One such round was measured on the upper-most level of Parking “B” (Figure 1), the final set being measured near the eastern edge of Parking “A”. The measurements atop Parking “B” confirmed the Penthouse noise sources as the primary noise offender, while those on Parking “A” were done to assess the noise impact relative to the City Noise Bylaw. These latter measurements indicated a resultant sound level of 51 dBA while all penthouse noise sources were running and a nominal 47 dBA with all Penthouse noise source shut off. Given the relative distances involved, it was determined that the Penthouse noise sources just met the City Bylaw allowable sound level of 50 dBA at the residential property line. Thus the options available to the Owner of the Research Tower were to (a) indicate to the noise-affected Resident that further action was not required or (b) implement some degree of noise mitigation despite not being required by law. The latter was chosen.

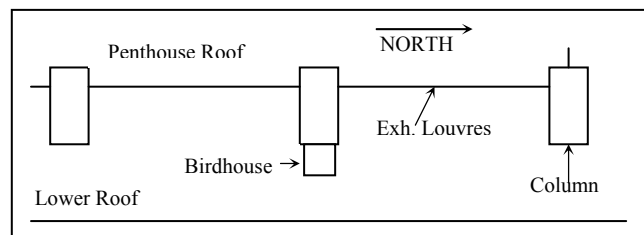
Figure 2 – Penthouse Area (Plan)

Figure 2 indicates the position of the falcon’s nest relative to the Research Tower’s exhaust-fan outlet louvres.

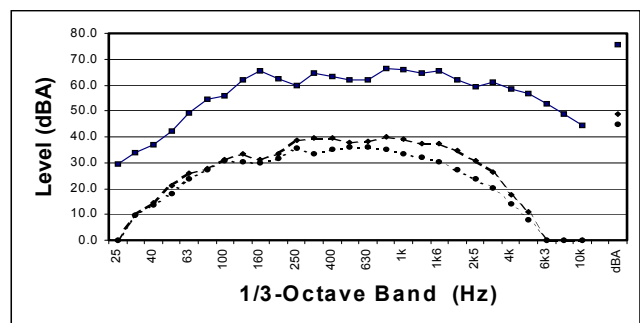
Figure 3 – 1/3-Octave Spectra

The upper (solid) line on Figure 3 indicates the 1/3-octave spectrum measured immediately near the Penthouse exhaust systems on the Research Tower. There is a local maximum centered on the 800Hz and 1000Hz bands. The second trace (dashed) on Figure 3 is the combined effect of all Penthouse noise sources in operation, as measured on Parking “A”. It is evident that the local maximum was still evident. The lowest (dotted) trace is the spectrum with all Penthouse noise sources off.
